# The Effects of High Strength and Associated Concrete Properties on Pavement Performance

PUBLICATION NO. FHWA-RD-00-161

1. Report No. FHWA-RD-00-161		2. Government Accession No.		3. Recipient's Catalog No.	
4. Title and Subtitle The Effects of Higher Strength and Associated Concrete Properties on Pavement Performance				5. Report Date June 2001

6. Performing Organization Code	
7. Author(s) W. Hansen, E.A. Jensen, and P. Mohr				8. Performing Organization Report No.	
9. Performing Organization Name and Address University of Michigan, 2340 G.G. Brown, Ann Arbor, MI 48109-2125				10. Work Unit No. (TRAIS)

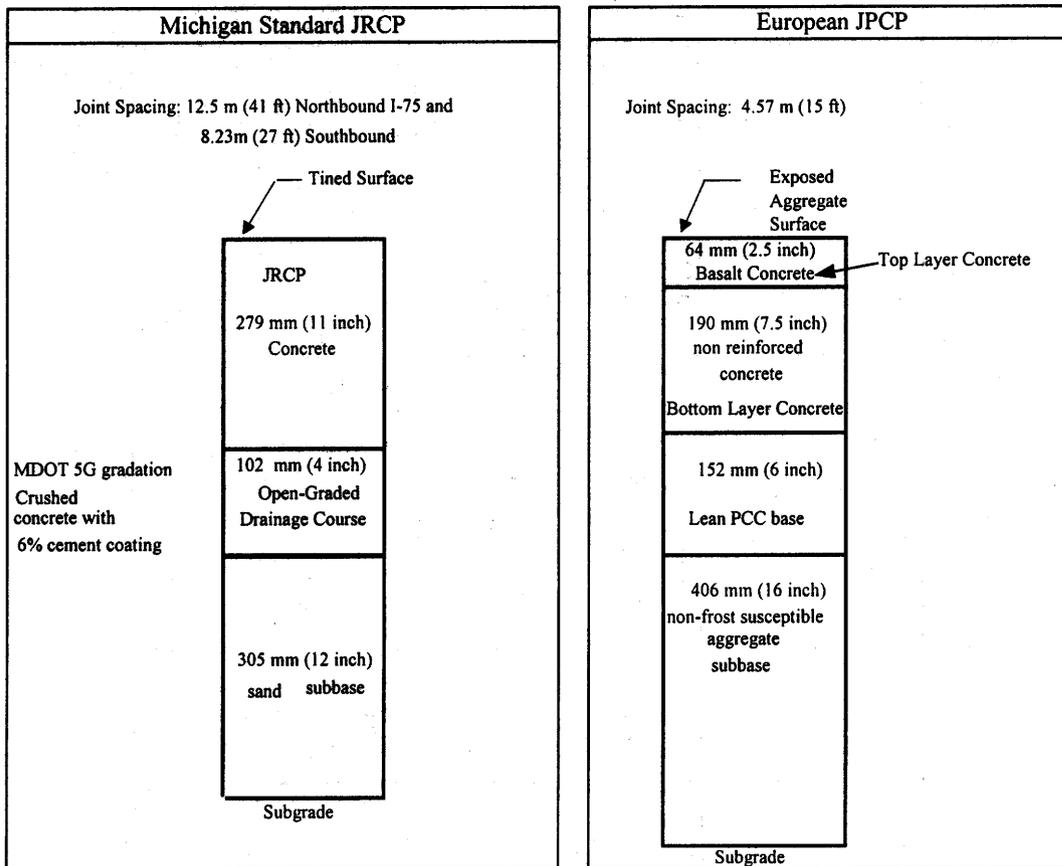
Figure 1.2.1 Pavement cross section for the European and the Michigan pavements on I-75, Detroit, Michigan.

Tables 1.2.2 and 1.2.3 show a comparison between the European and Michigan strength and mixture requirements and the mid-slab deflections from field measurements by falling weight deflectometer (FWD). The PCC mix designs are quite different as expected from the discussion in section 1.2.1. The pavement deflections of the European pavement are only about 50 percent of the deflections of the standard Michigan pavement. This is a substantial decrease in overall deflections and is attributed to the higher strength concrete (higher elastic modulus) and the bonded lean base.

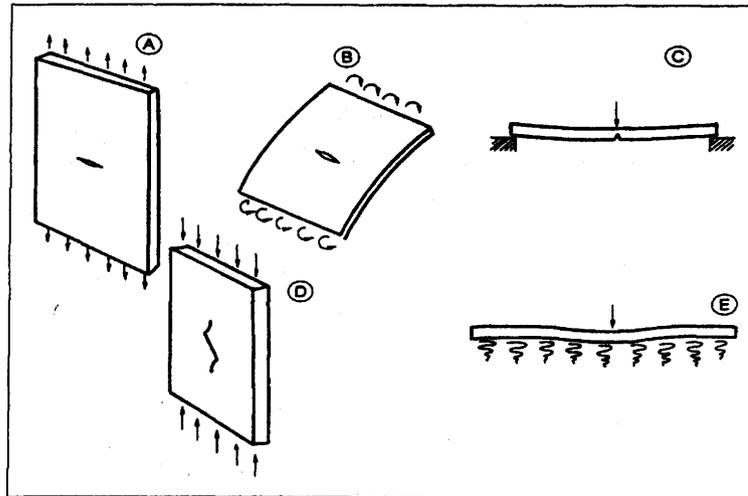
**Figure 1.4.1** Stable and unstable crack and loading configurations for PCC slabs. [After Bache and Vinding (1990/1992)]

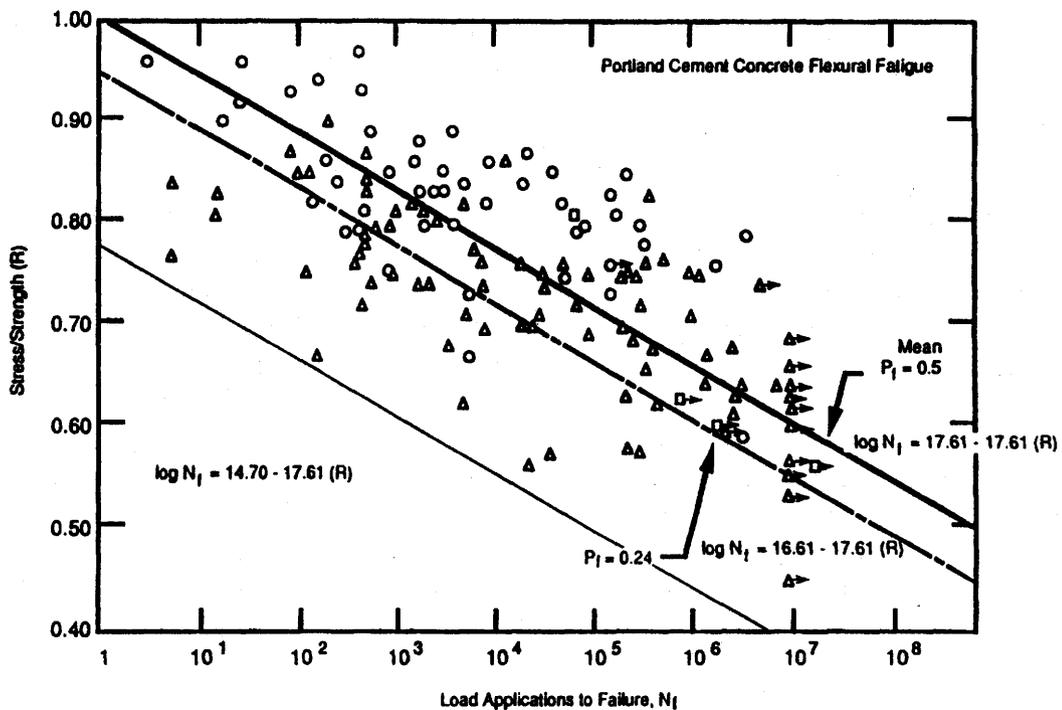
**Figure 1.4.2** Stress/strength ratio versus number of load applications. [After Mahoney et al. (1991)]

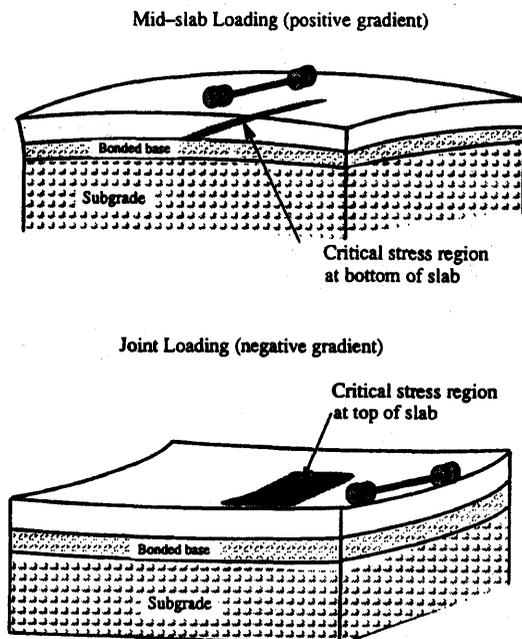
**Figure 1.4.3** Critical loading location with maximum tensile stresses for slabs in a dominantly upward or downward shape. [After Darter et al. (1994)]

Fatigue cracking can appear in concrete pavement due to the application of a large number of repeated traffic and environmental loads of various amplitudes. The traditional type of cracking is initiated at the bottom of the slab. The cracks induced by concrete fatigue can be transverse cracks initiated at the midslab edges, and longitudinal cracks initiated in the wheel paths at transverse joints (Huang, 1993).

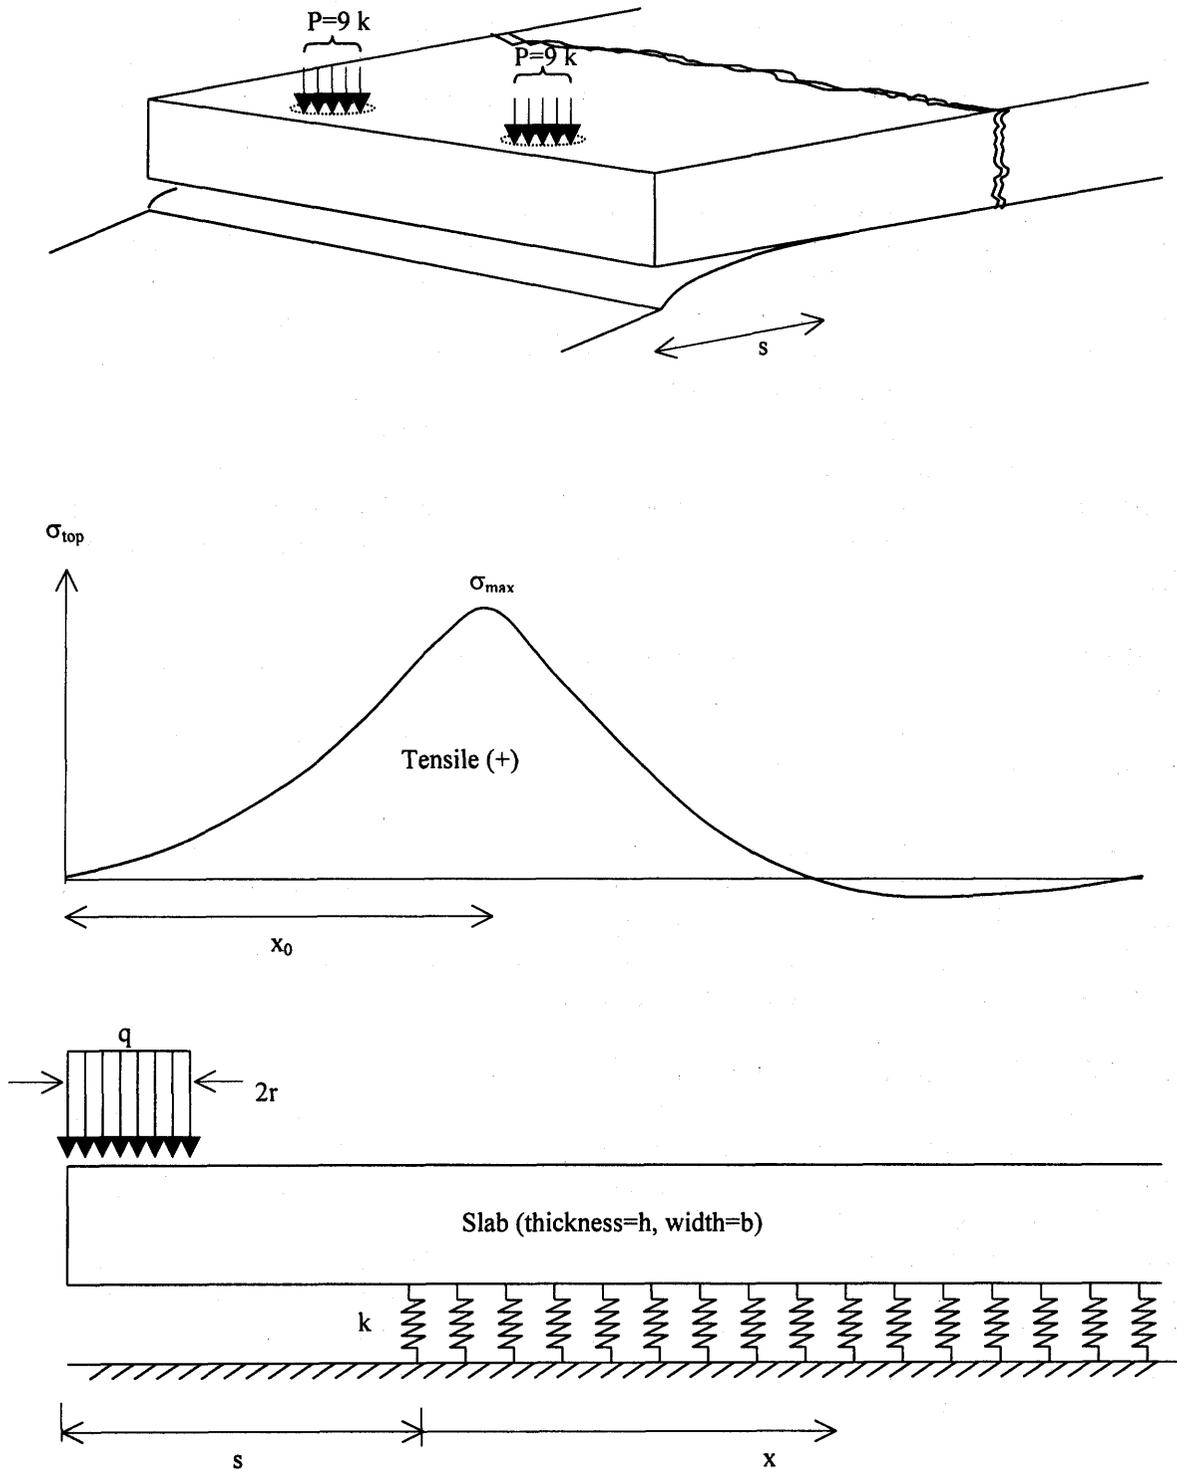
**Figure 1.4.4** Schematic of top-down cracking as influenced by foundation loss of support.

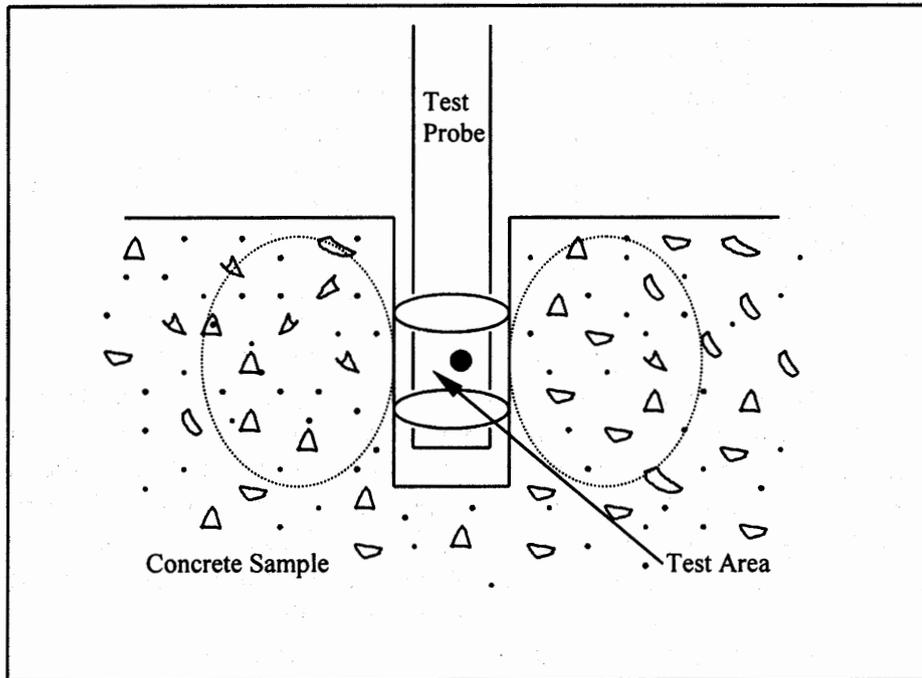
**Figure 2.4.1** Schematic of the water permeability test.

To perform a test, a 75- to 150-mm (3- to 6-in) deep, 22-mm (0.875-in) diameter hole is drilled into the concrete to be tested. The depth of the test region is adjustable from 32 to 89 mm (1.25 to 3.5 in). The test probe is then inserted into the hole and sealed off. The test probe is a hollow stainless steel shaft with a water outlet hole near the bottom. Neoprene rubber packers seal off the test hole above and below the water outlet hole to isolate the test area. This test set up is shown schematically in figure 2.4.1.

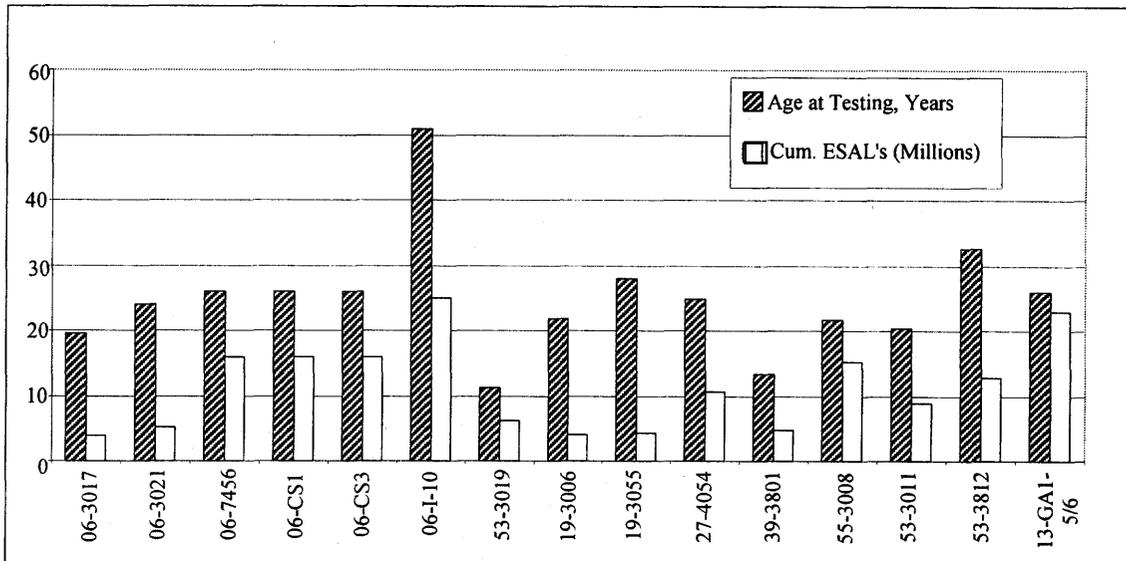
**Figure 3.1.1** Years in service and estimated cumulative ESAL's (millions) for the selected test sections.

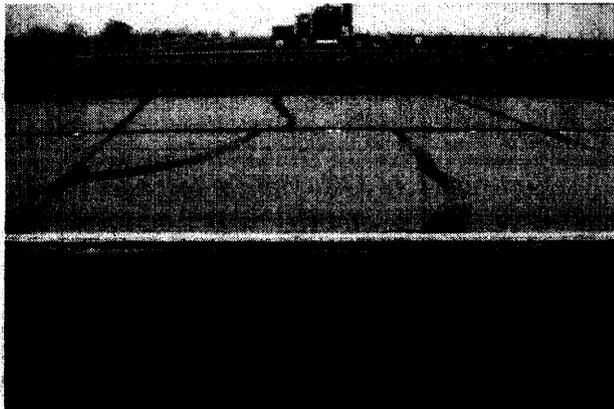
***Figure 3.1.13*** Corner break in truck lane at 06-CS3, Tracy Test Road (control section).

The test section was in fair condition. Low to medium severity transverse cracks were observed on 2/3 of the slabs, with only the 3.65-m (12-ft) slabs unaffected. There were two locations with low severity corner breaks. The test section had only a minor amount of faulting, on the order of 0 to 6 mm, with an average of 2 to 3 mm. Residue left from pumping of fines at the pavement edge adjacent to many transverse joints was observed. The concrete surface, the wheel path in particular, showed map cracking, but it did not appear to have affected the concrete durability or the concrete surface condition. This test section, 06-CS3, exhibited twice the number of transverse cracks as compared to the control section, 06-CS1, and also the amount of faulting was higher for this section. However, the spalling of this section was only half of that observed at the control section.

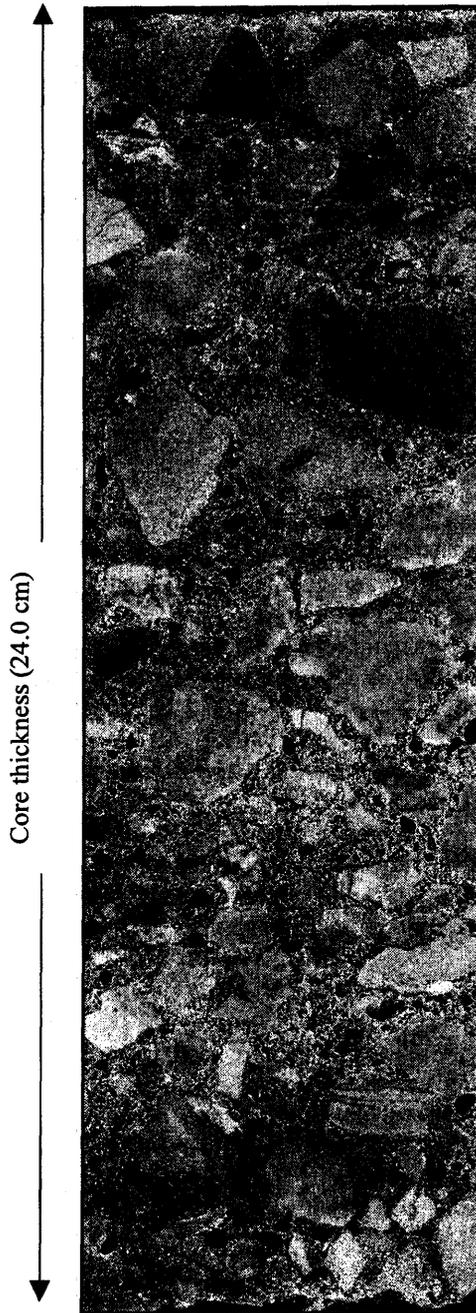
*Figure 3.2.10 Polished cross-section of pavement section 27-4054.*

The air voids are usually small reaching a maximum size of approximately 7 mm. A few of these larger air voids were observed at 1.8 to 5.2 cm and 18.8 and 20.5 cm into the drill-core. The air voids contain minor amounts of colorless and white precipitates. The white precipitates are most abundant in the lower half of the pavement section.

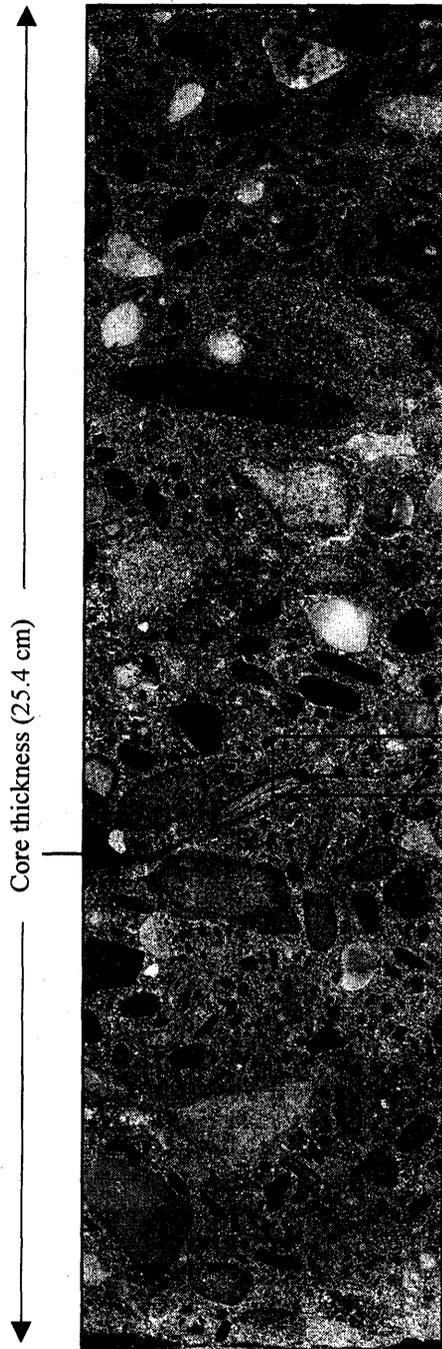
One of the slabs studied contained a horizontal open crack between 14.2- and 14.5-cm depth into the core (see arrows in figure 3.2.11). Note the wide crack in the boxed region formed after cutting and characterization of the slab. The maximum crack width ( $\ll 1$  mm) was observed around a larger air void in the sample. The crack cuts both paste and aggregates.

**Figure 3.2.11** Polished cross-section of pavement section 39-3801.

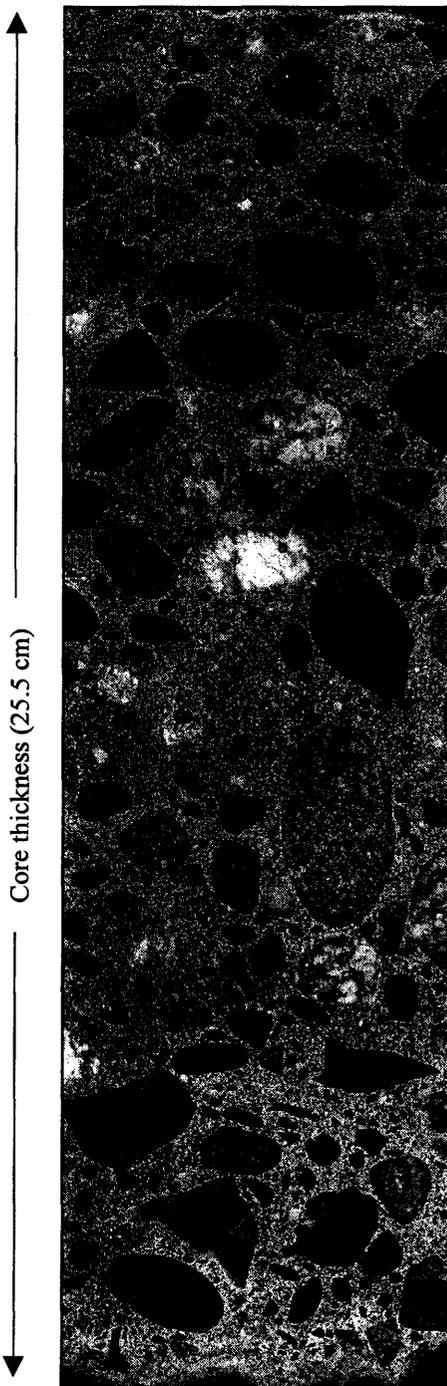
The number of air voids appears to be relatively high. Larger air voids ( $\leq 8$  mm) were observed in the top 7 cm, as well as the lower 11 cm of the core. The air voids in the lower 8 cm of the core were frequently partially filled with white precipitates which sometimes occurred with needle-shaped morphology.

**Figure 3.2.13** Polished cross-section of pavement section 53-3011.

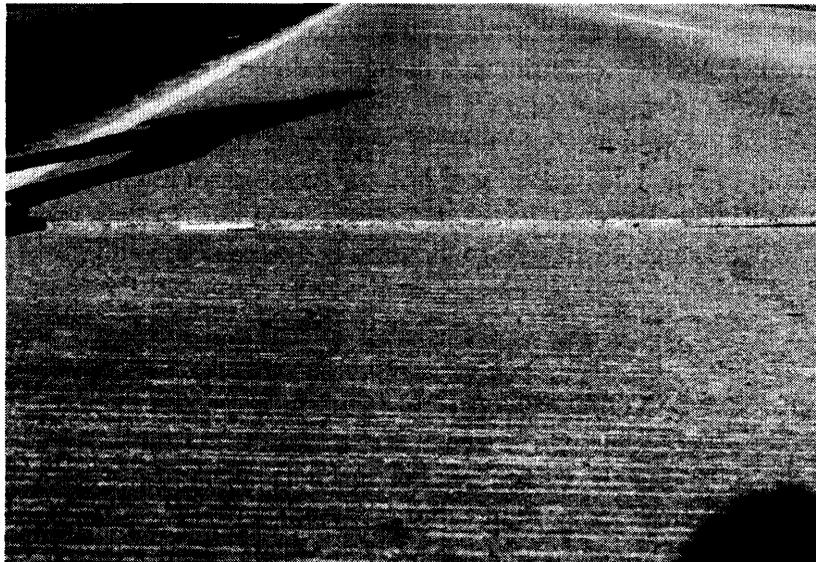
*Figure 4.2.1 Faulted transverse joint in test section 55-3008.*

In addition to the rotation, the slabs are curved upward at approach joints, consistent with pumping of fines in the presence of water from the leave side to the approach side of a joint. The foundation is forgiving, which has allowed the slab to settle and develop substantial permanent upward curved shape, thereby reducing loss of support. Excellent agreement was obtained between the profiles in the outer and inner wheel paths.

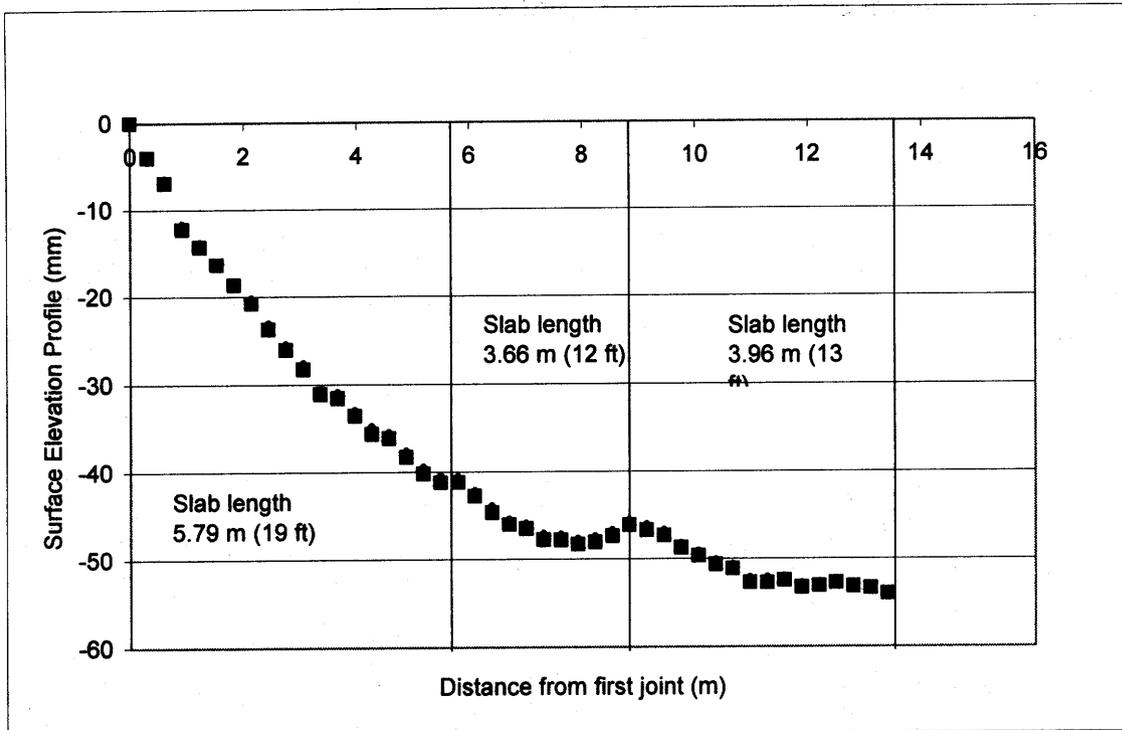
**Figure 4.2.4** Surface elevation profiles for 06-7456 at Tracy. The design slope is not extracted from the profiles.

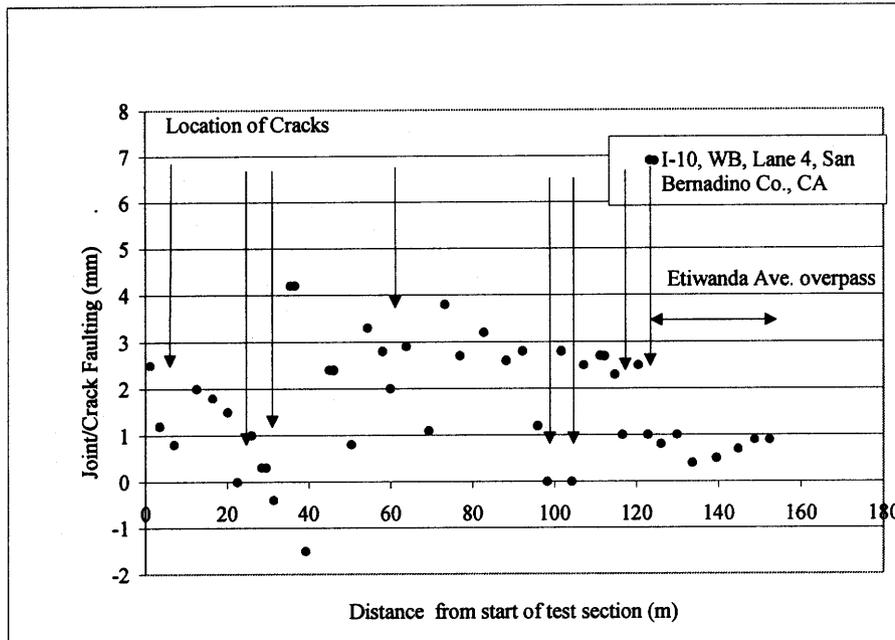
**Figure 4.2.6** Joint/crack faulting measured along the outer wheel path in the direction of traffic for the 153-m test section, 06-I10 in California.

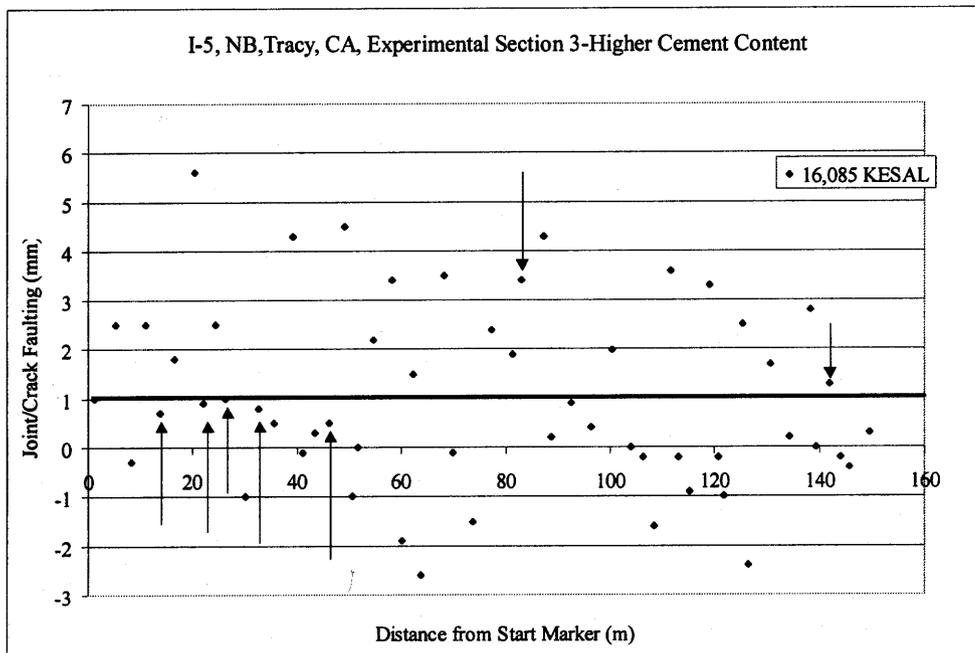
**Figure 4.2.7** Joint/crack faulting measured along the outer wheel path in the direction of traffic for the 153-m test section, experimental test road 06-CS3 near Tracy, California.

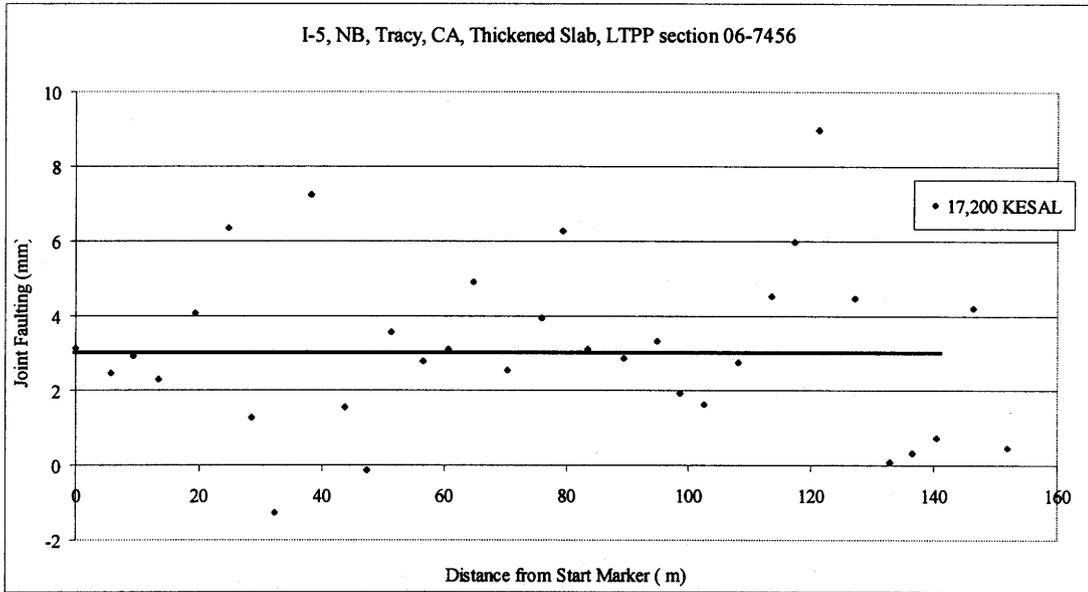
**Figure 4.2.8** Joint/crack faulting measured along the outer wheel path in the direction of traffic for the 153-m test section experimental test road 06-7456 near Tracy, California.

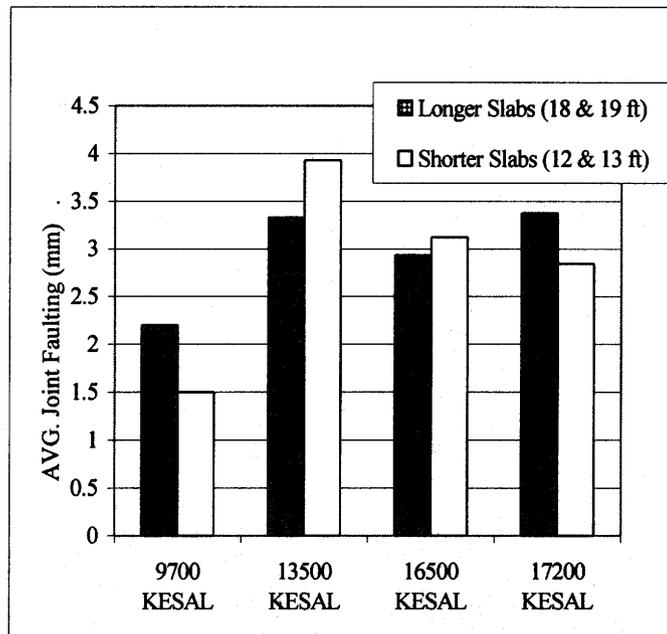
**Figure 4.2.9** Joint faulting for slabs of various lengths for experimental test road 06-7456 near Tracy, California at different cumulative traffic levels.

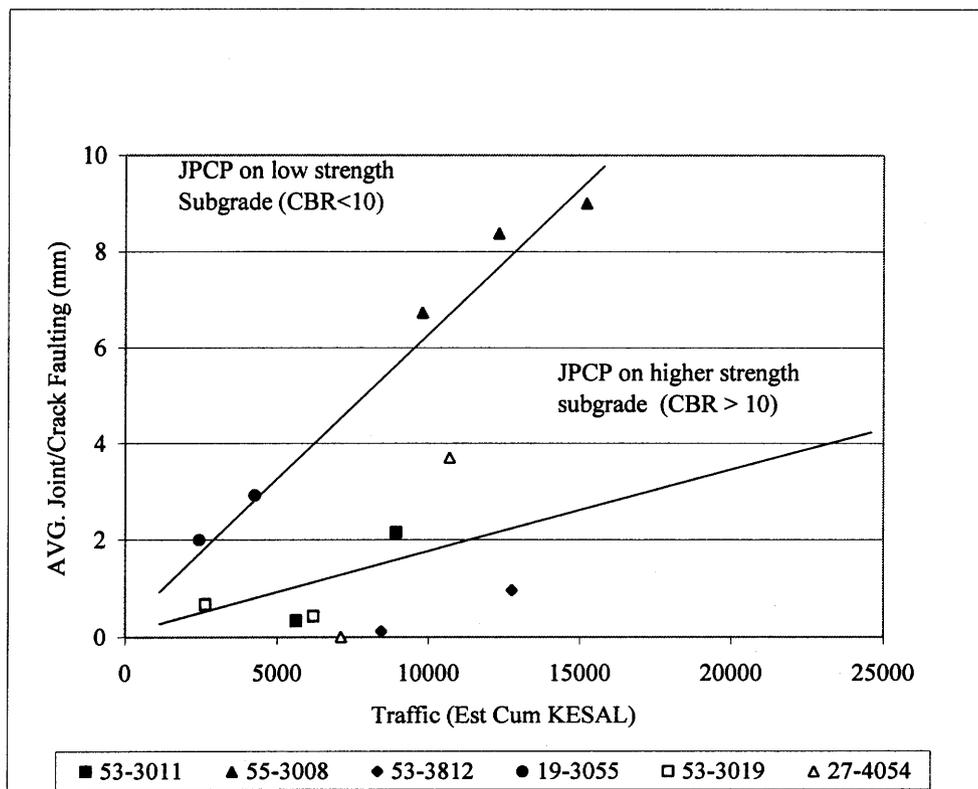
Figure 4.2.12 Faulting development versus traffic for JPCP on granular bases.

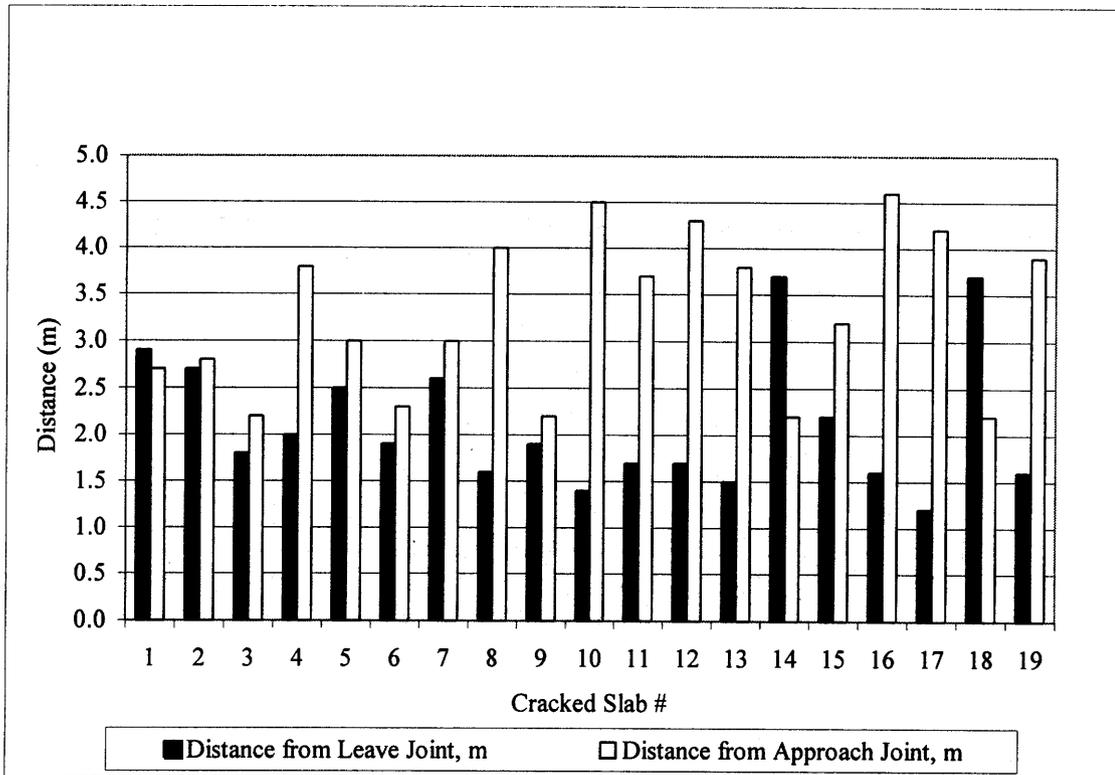
**Figure 4.3.2** Location of transverse cracks from joints for section 06-CS3.

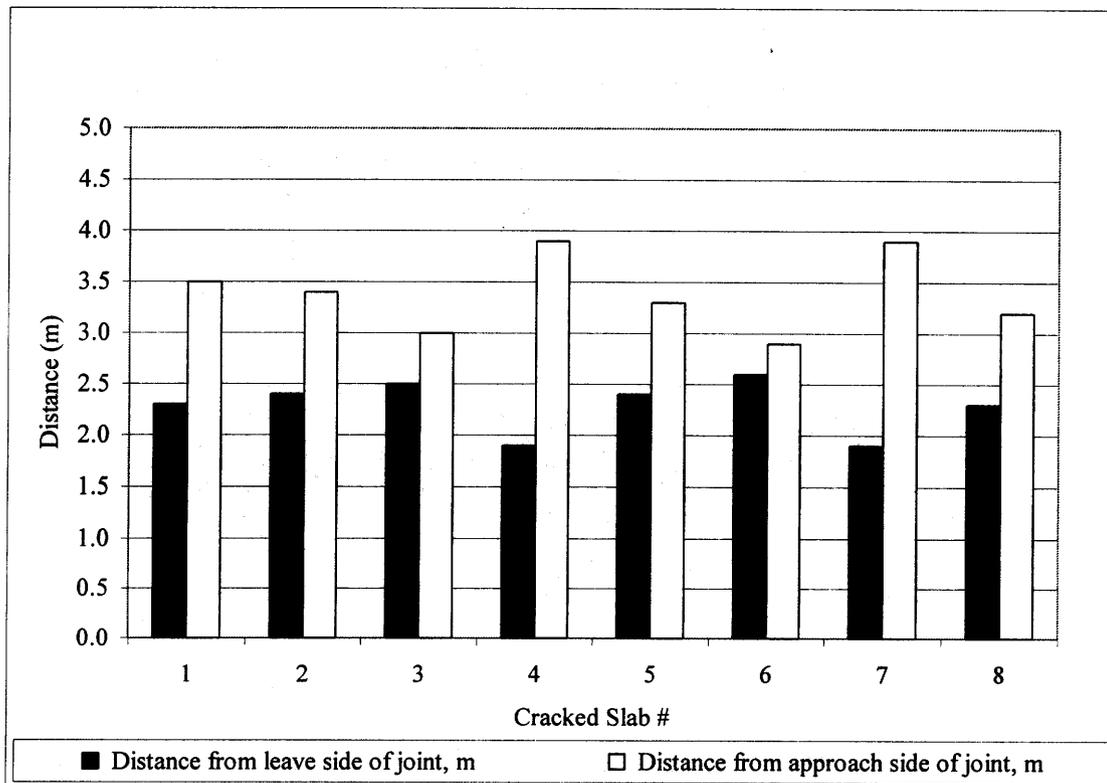
**Figure 4.3.3** Location of transverse cracks from joints for section 06-I10.

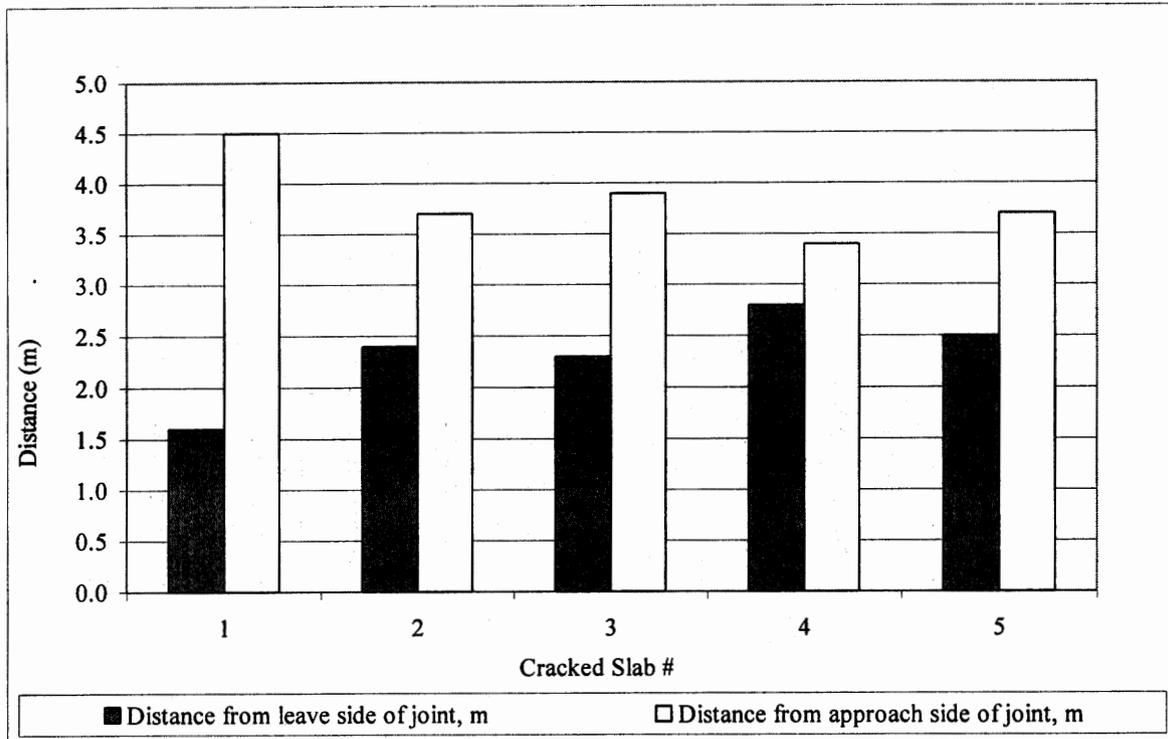
*Figure 4.3.4 Location of transverse cracks from joints for section 19-3006.*

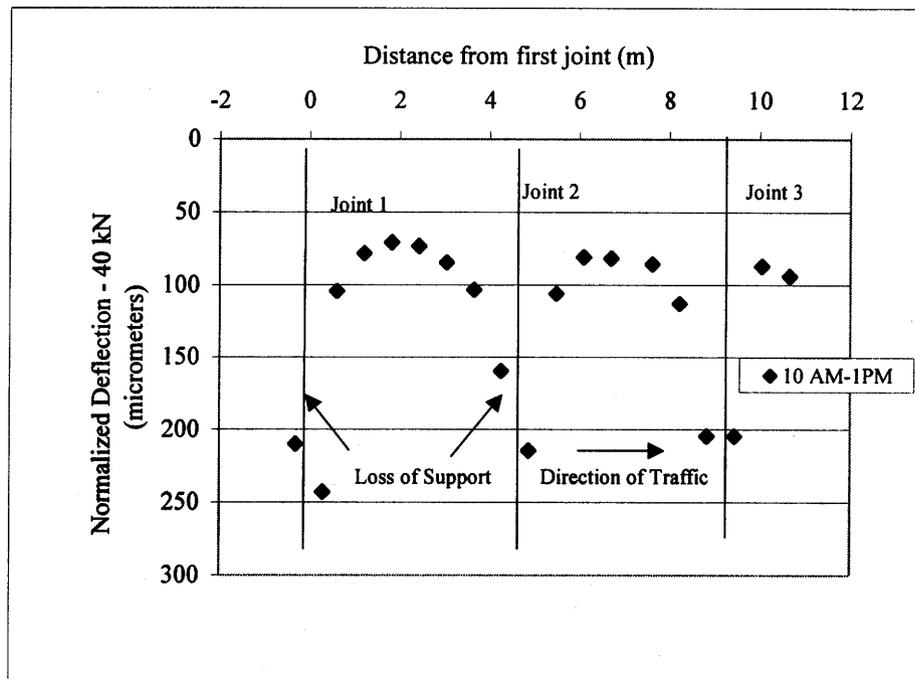
**Figure 4.3.6** FWD slab profile for two slabs on 06-7456 near Tracy (thickened slabs). (Increased edge deflections indicate loss of support.)

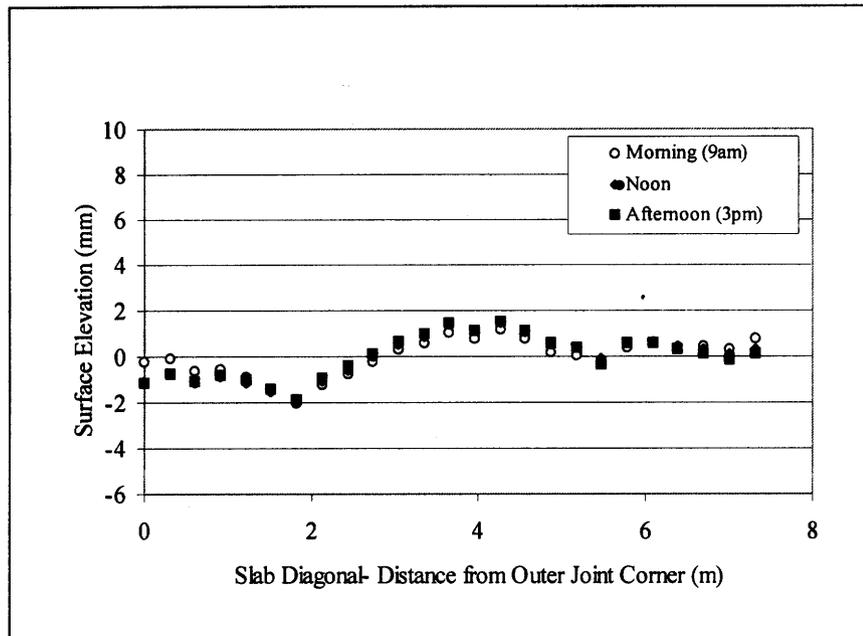
**Figure 4.3.11** Surface elevation profile for 13-GA1-5.

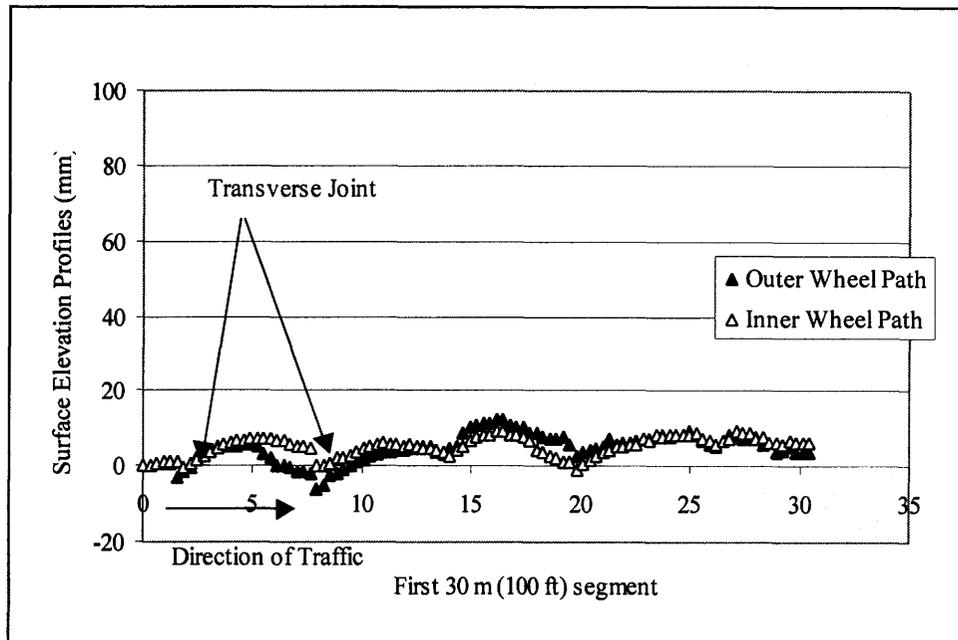
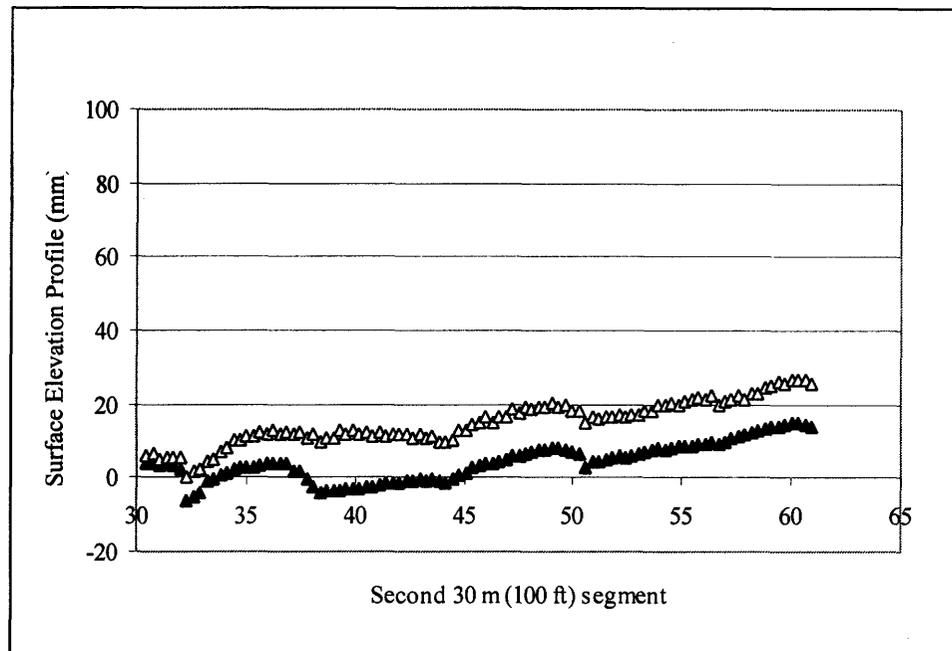
**Figure 4.3.12** Surface profiles for test section 19-3055.

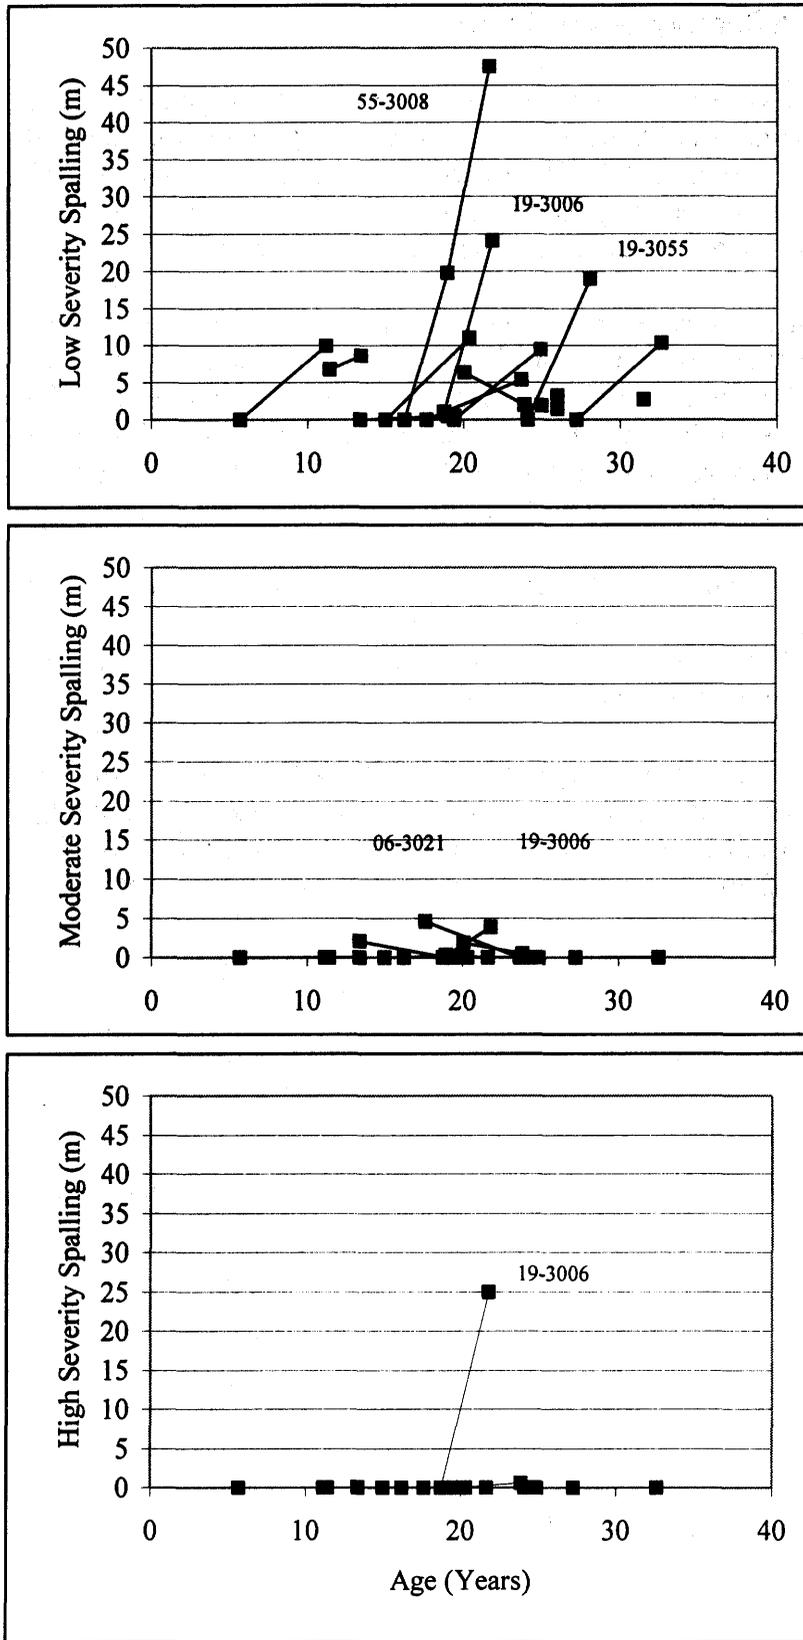
**Figure 4.4.1** Development of spalling over time for the investigated test sections. (Spalling is categorized as low, medium, and high severity.)

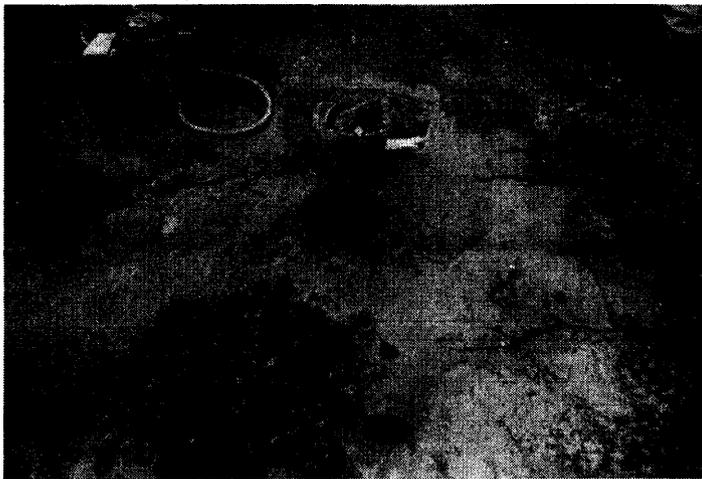
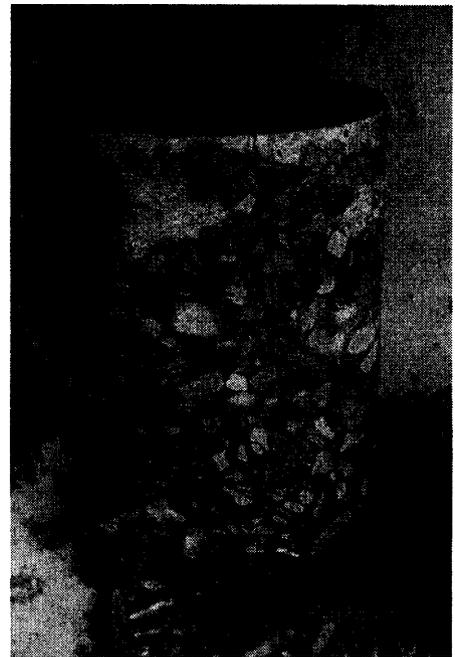
*Figures 4.4.3 Close-up photos of joint deterioration from test section 19-3006.*

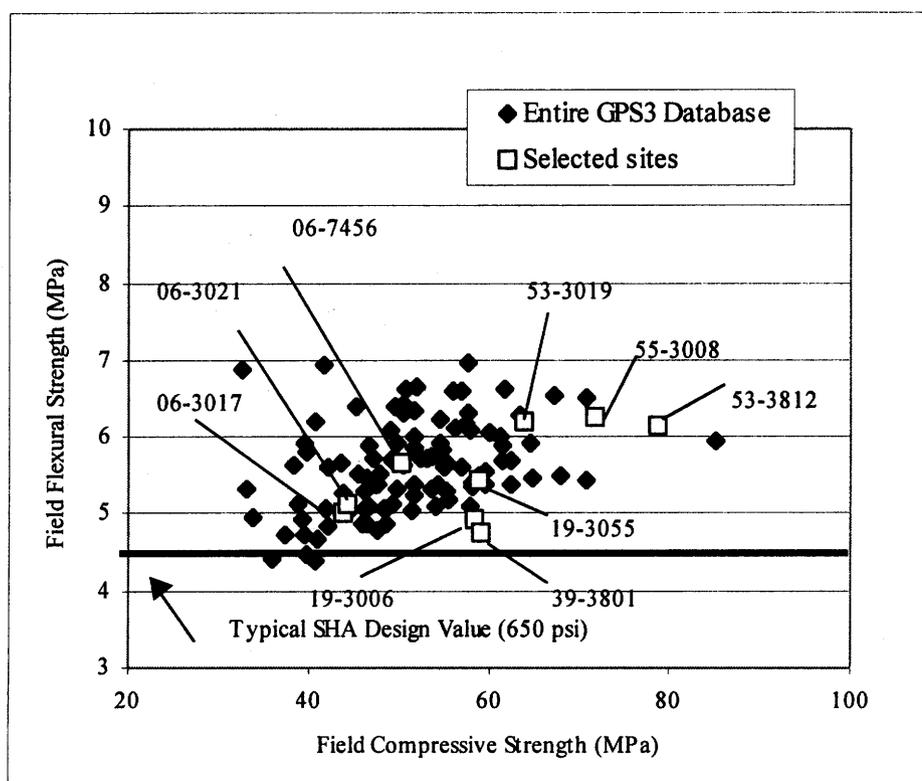
*Figure 5.1.1 Field flexural strength versus compressive strength for the test sections available in the LTPP database.*

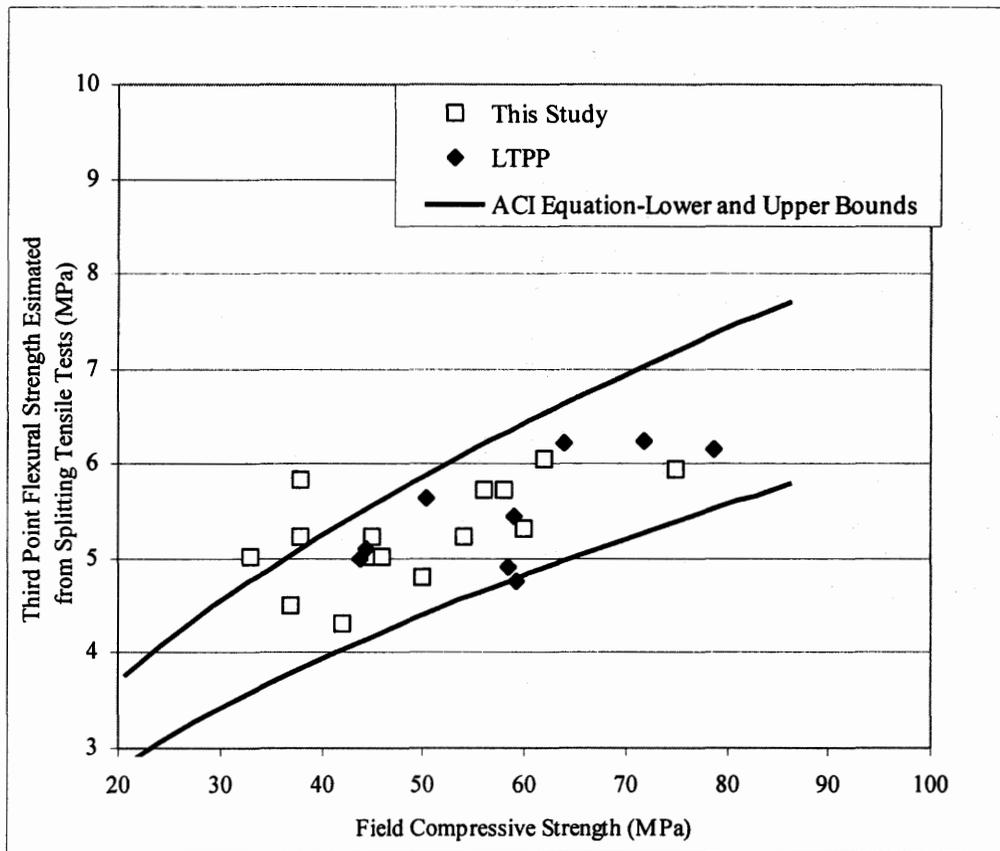
**Figure 5.1.3** Estimated field flexural strength versus field compressive strength for the 15 test sections in this study.

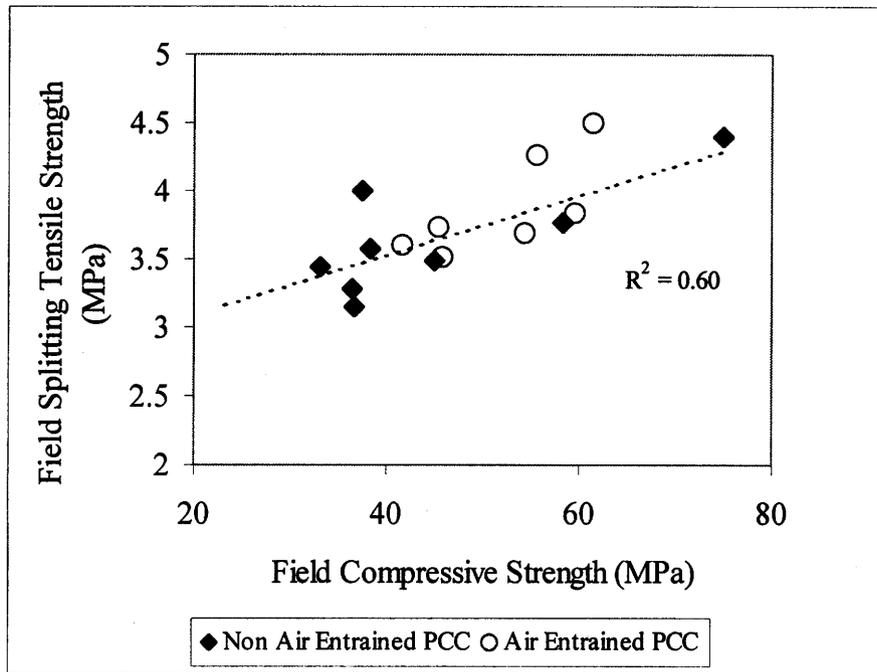
**Figure 5.3.1** Ultimate splitting tensile strength versus ultimate compressive strength for field specimens.
